July 9, 2015

Subject: Red and Bonita Mine, Silverton, CO
Site Visit Summary and Ground Control Plan

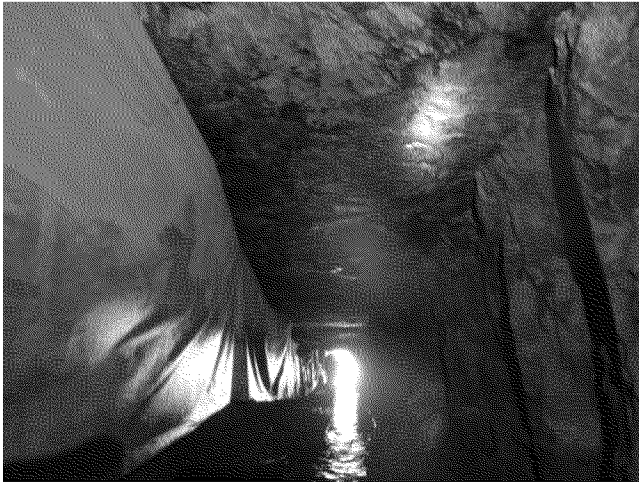
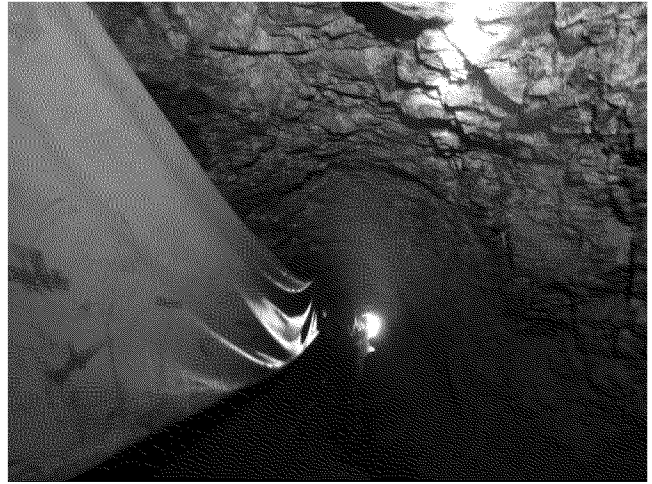
Per the geologic map, there is considerable variation in the local orientations of the fissures, faults, and veins in the vicinity of the Red and Bonita Mine and this was apparent within the tunnel with various sections of the tunnel demonstrating prominent jointing and others exhibiting random jointing. Due to the considerable variation in jointing, no discontinuity measurements were taken during the site visit.

Photos 1 & 2: Contrast in Rock Jointing and Tunnel Section
(Well defined jointing and rectangular profile (left) vs. numerous random jointing and rounded profile (right))

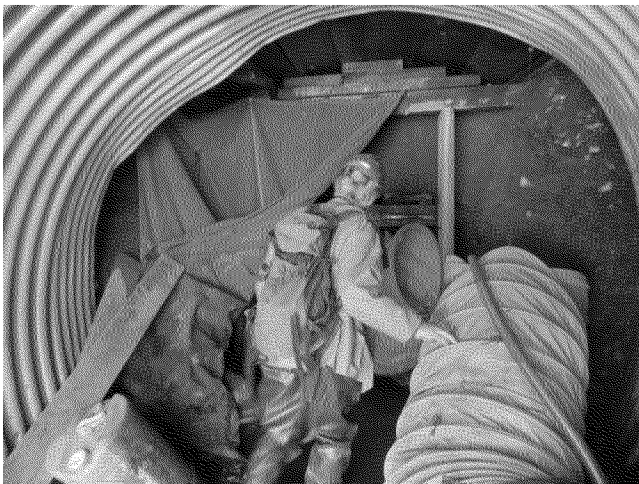
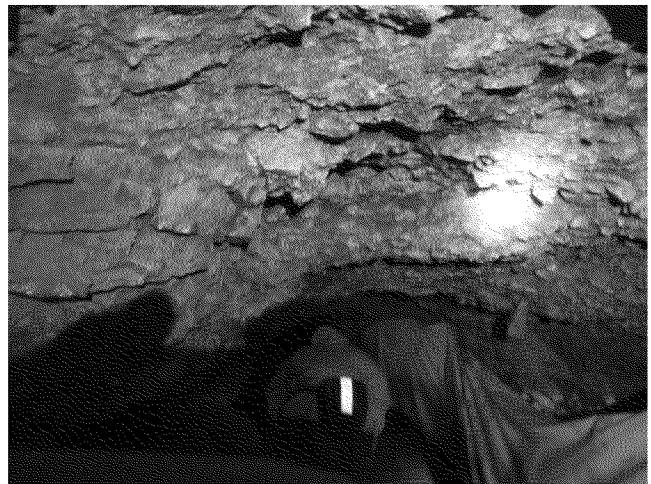
The portal area has been supported by a corrugated metal pipe, overhead timber lagging, and dual timber square sets (one large and one small) within the past few years. Inby from the portal, the rock consists of a breccia, basically a conglomerate comprised of angular rock fragments in a cemented matrix, for the first 40 to 60 feet. Although the matrix material appears to be weathered, limited probing and hammer impacts indicate that the breccia is well cemented. The majority of the rock surfaces were stained and no recent or visible rock falls were apparent in the breccia.

Photos 3 & 4: Initial Main Drift in Breccia near Portal

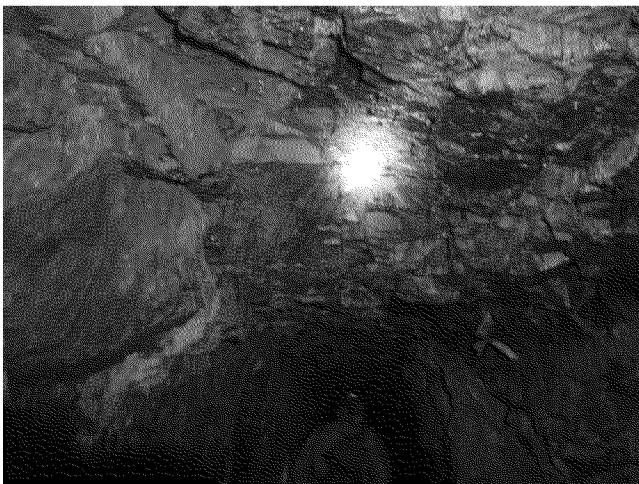
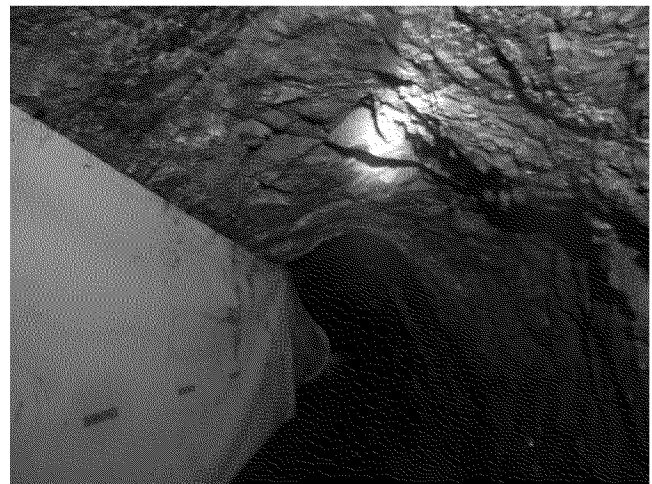
Photos 7 & 8: Typical Main Drift Rock Conditions

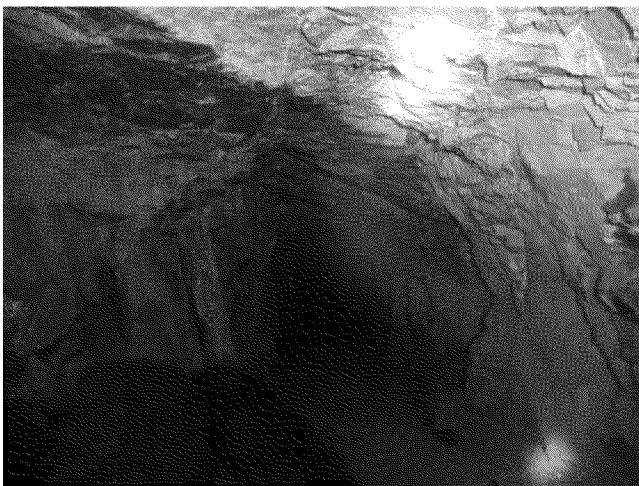
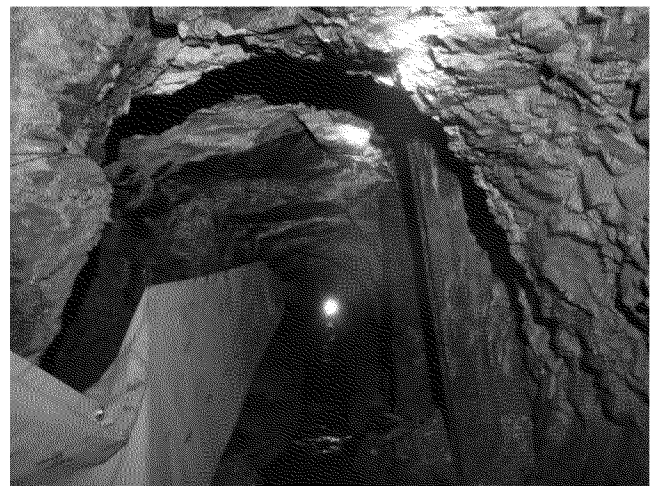
In addition to the recent timber support at the portal, there were three areas that showed evidence of timber support. The first area was at the junction of the 275-Drift with the main adit where several round vertical posts are located adjacent to the junction; only one of these posts was blocked to the overlying rock (275-Drift) with the others in the main drift simply remnants of prior support. No evidence/debris of prior extensive timber support (such as timber sets or lagging) was observed in the invert. There does appear to be fresh rock surface overlying the junction and it is unknown as to whether this area was recently scaled. Regardless, the current rock conditions appeared to be stable and competent and do not appear to require supplemental support.

Photos 9 & 10: Junction of 275-Drift with Main Drift (Looking down 275-Drift with blocked timber post (left) and main drift looking outby with overhead fresh rock exposure and remnant posts (right))

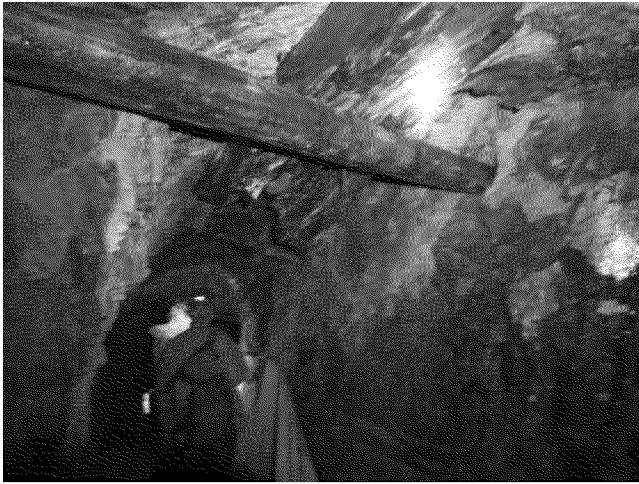
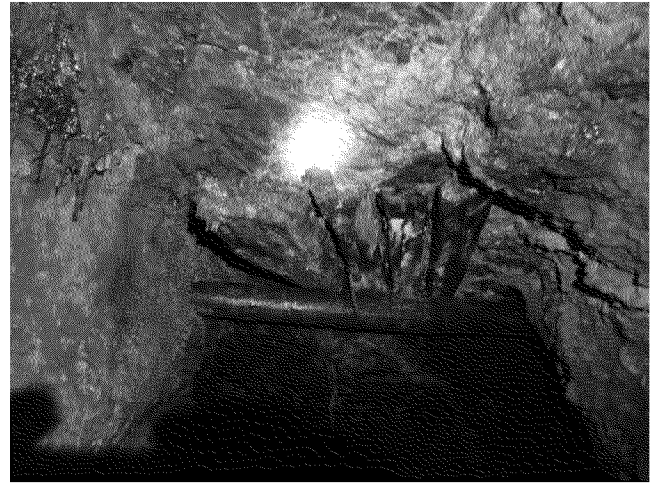
At the junction of the Main Drift with the Northern Heading, a single round timber stull is located in the crown and supports several lagging boards while a second unloaded/unlagged timber stull is located inby. Limited probing of the stull and lagging with a geologist hammer indicates that the point is readily able to penetrate the outer 1/8" to 1/4" into the timber before relatively solid timber is reached. The timber support system appeared intact and no obvious signs of either distress or decay were observed. There appears to be less than 6" of rock debris loading the lagging and thus, for the heavy timber stull and lagging, the timber system is very lightly loaded. Based on the unsupported and exposed rock conditions surrounding the timber lagged area, consideration could be given to removing the timber supports and scaling the crown, however this presents some inherent rockfall risk and it is believed that leaving the timber in place and undisturbed is the best alternative given the current stability of the timber support and limited amount of construction access that is needed beyond the bulkhead and cofferdam area.

Photos 11 & 12: Isolated Stull and Lagging Support within Northern Drift near Junction of Main Adit Drift (looking inby with second stull visible in distance (left) and looking outby (right))

The timber supported areas are located where construction activities will be limited and the timber supports do not appear to be heavily loaded and appear capable of maintaining the opening stability throughout the anticipated construction duration. As a precaution during construction, it is recommended that personnel avoid lingering below the timber supported areas or disturbing the existing timber members.

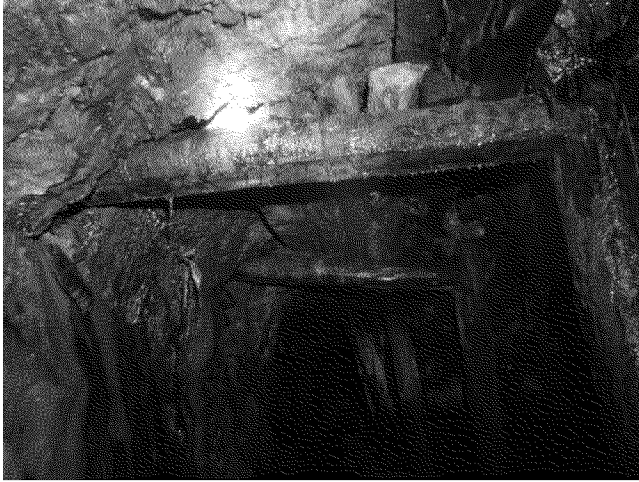
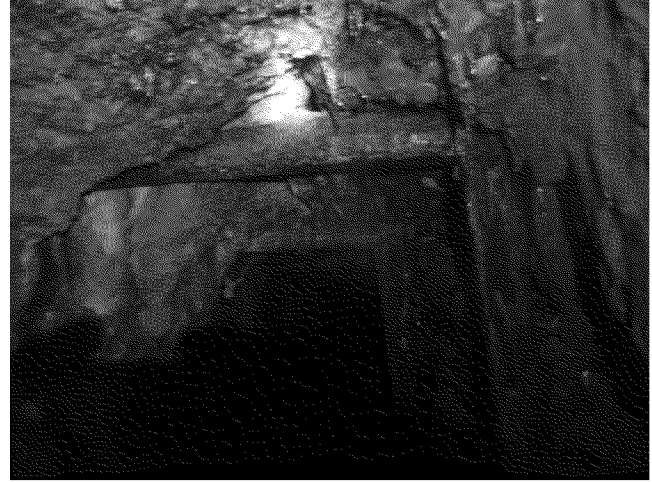
A more extensive timber lagged section exists further inby on the Northern Drift beyond an open stoped area where the adit appears to be following a mineralized vein. This area consists of a single post blocked to the rock followed by numerous sets of partial timber rib sets with overhead lagging and side lagging, timber stulls and lagging, followed by partial timber rib sets and crown lagging. The partial timber rib sets consists of a round timber post supporting a round horizontal beam which is keyed, wedged, or resting upon the inclined side wall; posts are on the left inby rib on the downstation end and on the right inby rib on the upstation end. Examination of the overhead conditions near the upstation end indicates a stoped area of approximately 6 feet above the timber lagging and approximately 1 vertical foot of rock debris loading the lagging. Similar to the other stulled section, probing with the point of the geologic hammer revealed that the interior of main timbers are solid with approximately 1/4" of penetration. The timber support system appears to be intact with no missing main members. The timber lagging overall appears to be in place with the most distressed lagging occurring in the sidewall on the downstation end of the supports. None of the main support members appeared stressed or overloaded and the overall system appears to be stable. The combination of the limited construction activities intended for the Northern Drift, the current stability of the timber system, and the limited rock loads acting on the timber system indicates that the probability failure during construction will be low. Although currently stable, it is recommended that a common sense approach be adopted during construction that avoids disturbing the existing timber supports and minimizes both the number of personnel and the duration that personnel will be below the timber supported areas.

**Photos 13 & 14: Partial Timber Rib Sets and Lagging in Northern Drift
(looking outby)**

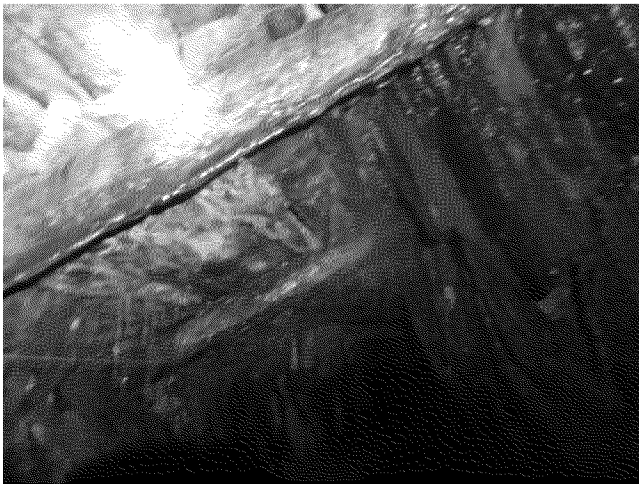
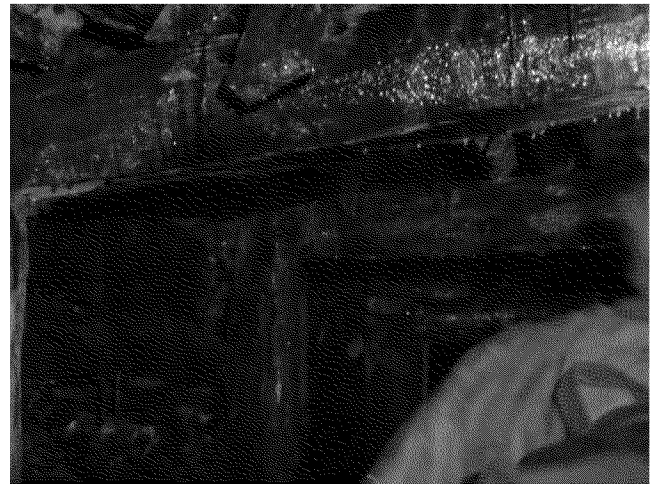
Photos 15 & 16: Stull and Lagging Support (left) and Partial Rib Supports (right) within Northern Drift

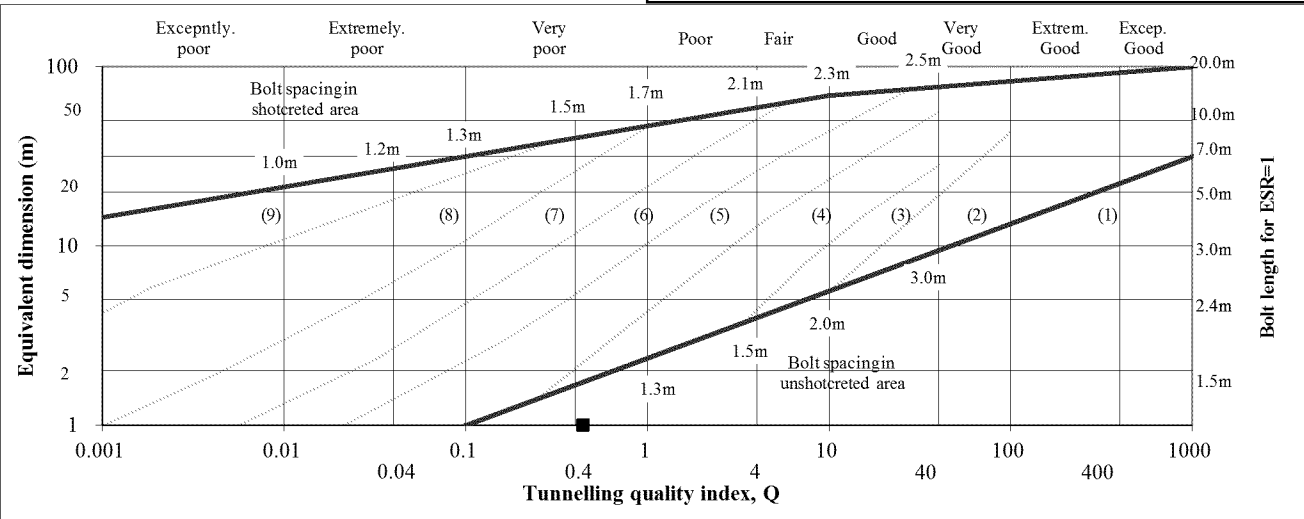
As an independent check of the self-supporting capabilities of the rock, the NGI Tunnel Quality Index rock mass classification system (Q-system) was utilized to assess the rock support requirements for the typical adit assuming pessimistic rock conditions. Per the attached Q-system evaluation, the small adit dimensions do not require any supplemental support for the worst rock conditions observed. The majority of the drift has rock conditions better than utilized for the evaluation, indicating even more stability. This confirms the field observations of adequate unsupported adit stability during the site visit.

Block Size (=RQD/J _n)		3.333
Inter-block strength (= J _r /J _a)		1.000
Active Stress (= J _w /SRF)		0.132
Tunnelling Quality Index	Q	0.440
Equivalent Dimension	D _e	1
